Arborist Report – Tree Health and Structure

Property Address

6 June 2015

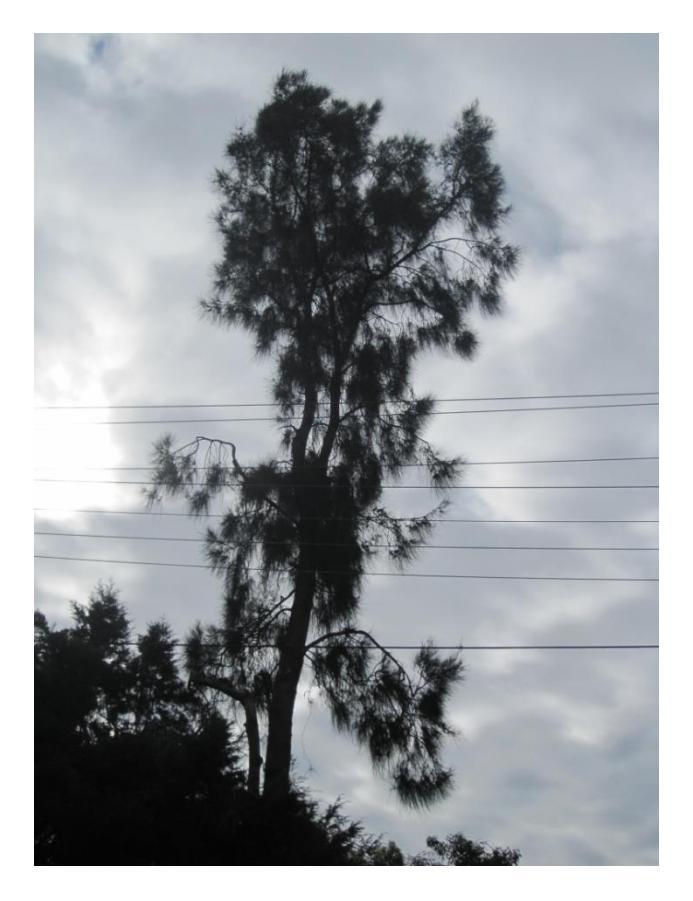
Photo of tree #1

- Tree genus and species Casuarina cunninghamiana
- Common name River She-oak
- Tree health Fair
- Tree structure Fair-poor
- Tree form Poor
- Tree height and width ~15x9m
- Diameter at breast height (DBH) 48cm
- Tree age Mature
- Useful life expectancy (ULE) 5-15 years
- Tree retention value Low

Remove tree.

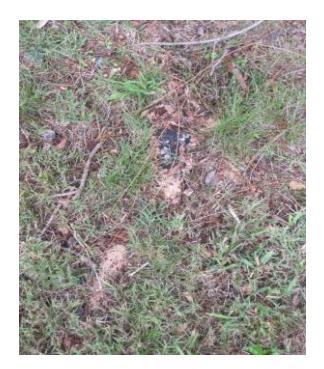
One surface root was seen in the front yard of the subject site. There is a wound on the top side of the root, with some decay present. It appears to have been damaged by a mower (see figure 2).

Figure 2 – shows the damaged and decayed tree root.

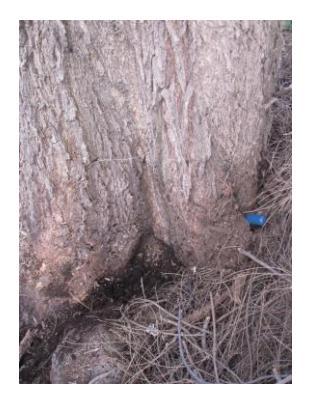
There are two wounds with decay present at the base of the tree. One on the north side of the lower trunk beginning at ground level and the second is on the west side, also at ground level, see figure 3.

Wounds and decay such as this could lead to bark delamination in the future and could be the result of a fungal pathogen. A fungal pathogen, or biotic disease, may cause injury to trees through continued irritation of structural timber, which can lead to a reduction in structural strength (Harris, Clark & Matheny 2004).

Figure 3 – shows the two wounds at the base on the tree. The blue screwdriver indicates the depth and location of the second.

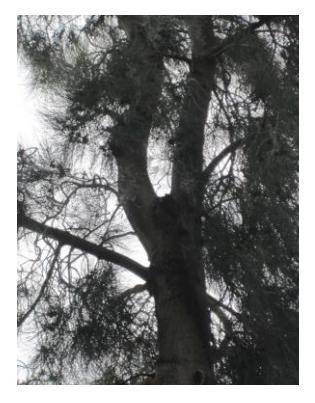
The structure of the trees main stem and larger scaffold branches appears to be fair-poor. The tree has a single trunk to approximately 10m above natural ground level, where codominant stems have developed, see figure 4. Watson (2006) states that co-dominant stems are considered to be weaker than a healthy lateral branch union containing a branch bark ridge. Reaction wood (or ears) have grown on the west side of the codominant stems indicating a sign of improved strength, however it still shows actual weakness within this attachment (Watson 2006).

Figure 4 – shows the codominant stems in the subject tree.

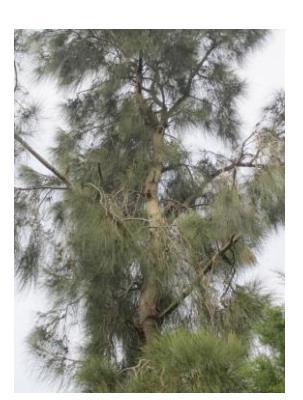
As a result of the branch failures, this tree has a significant limb failure history. As many as 12 branches have failed over the last few years. As recently as February this year three

branches, up to 10cm in diameter, have failed with one knocking a Telstra line off the house. There is clear and visual evidence of the significant amount of limb failures within the canopy of this tree, see figure 5.

The form of the tree is poor, which is a direct result of the limb failures. It is possible that as this tree has been progressively pruned away from the high and low voltage power lines it has left other branches within the crown more exposed to wind loads, which has lead to failures. As even more failures have occurred it again has exposed many remaining branches to wind loads leading to even more branches failing. Given the existing form, limb shed history and open crown, more branch failures are likely.

Figure 5 – shows the

failures.

locations of many branch
