Arborist Report – Tree Health and Structure

Property Address

6 June 2015

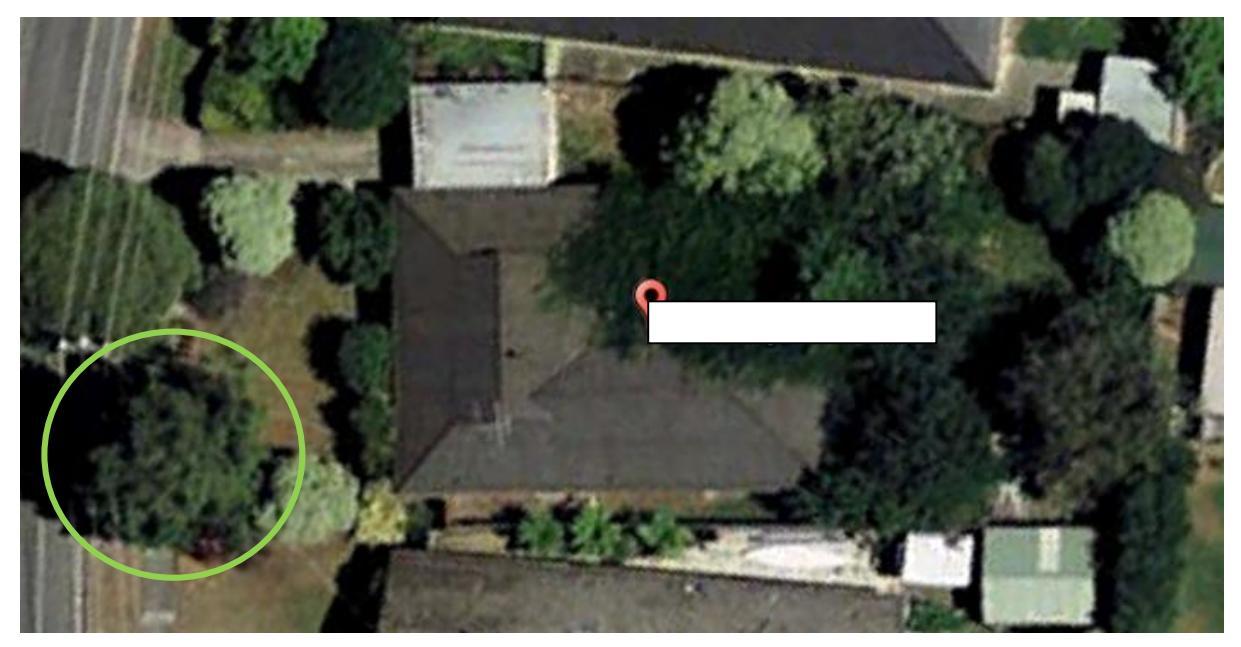
This tree is located on a suburban property in (XX address), which is approximately 26km east of Melbourne. The tree is positioned within the front yard of the site on the south-west boundary (see figure 1).

Figure 1 – shows the location of tree #1 within the subject site.
